Debris/Ice/TPS Assessment and Integrated Photographic Analysis Of Shuttle Mission STS-100

**DEBRIS/ICE/TPS ASSESSMENT
AND
INTEGRATED PHOTOGRAPHIC ANALYSIS
OF
SHUTTLE MISSION STS-100**

April 19, 2001

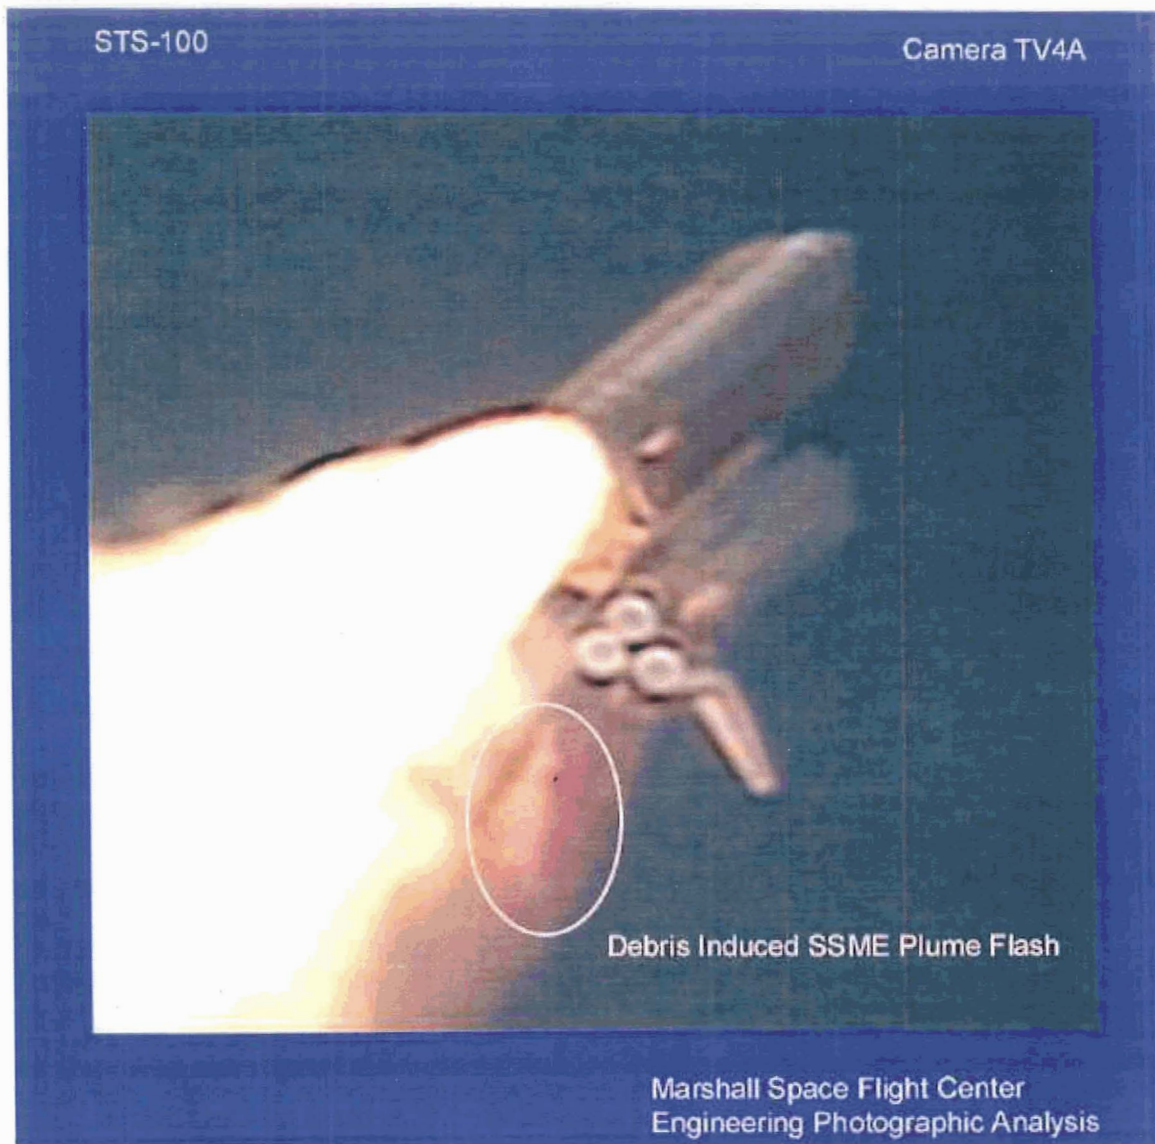
A debris induced streak in the SSME plumes was noted on Video Camera TV-4A.

Figure 13. Debris Induced Streak in SSME Plumes

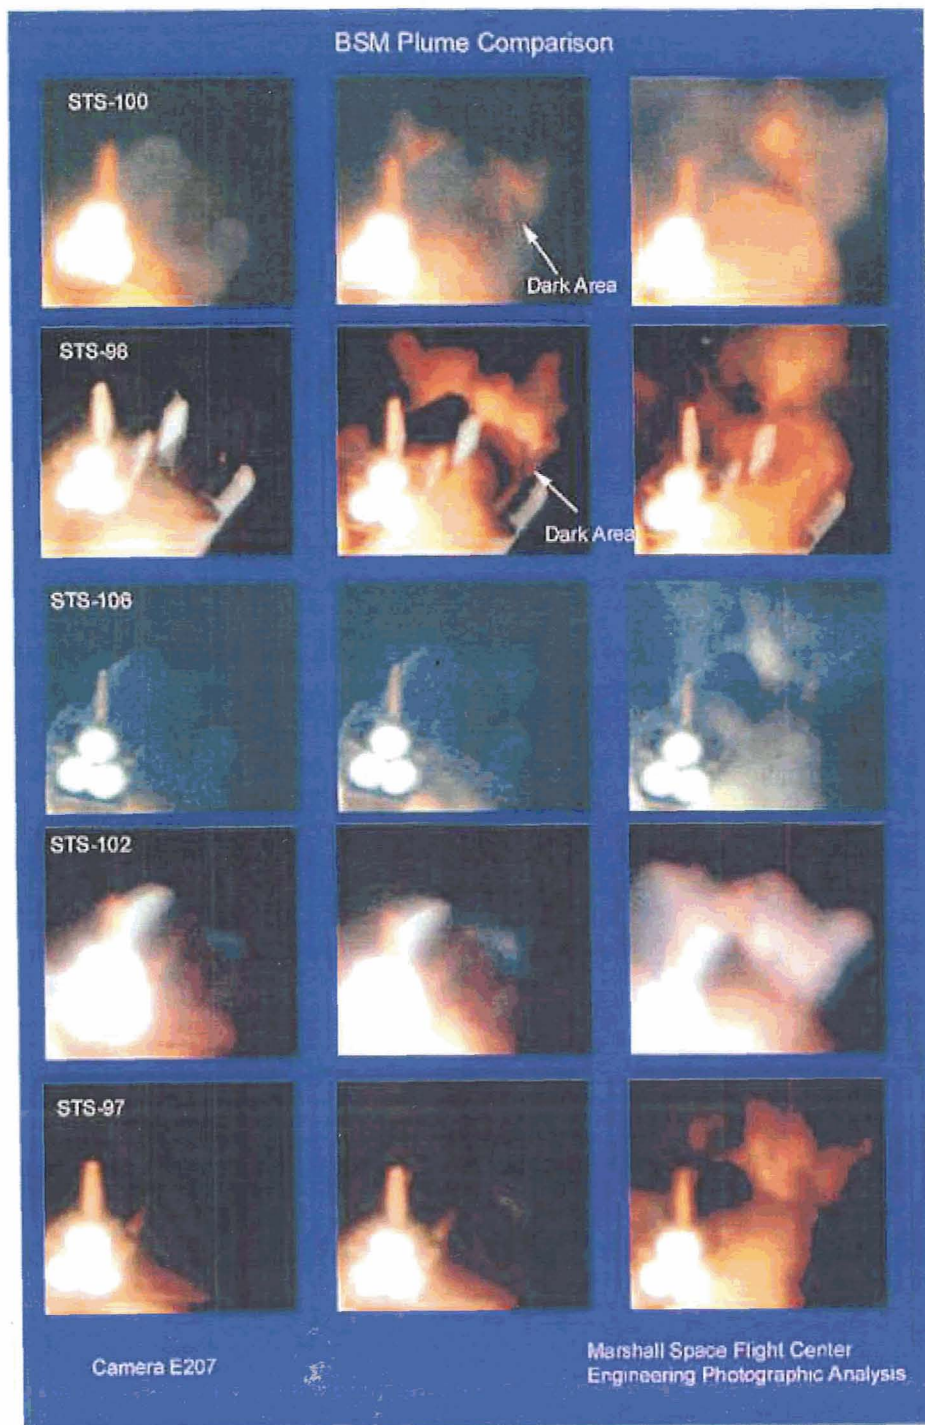
Figure 15. Comparison of BSM Plumes for Several Recent Missions

A comparison of the BSM Plume structure from several recent missions was made. No significant differences in plume performance or shape could be discerned. The dark area observed on mission STS-100 in the BSM Plume was visible in the BSM Plumes on mission STS-98, but was not visible on the other missions. Results of this visual study indicate that the dark area in the BSM plumes is probably not attributable to BSM flameout and the dark area is more likely caused by shadows or camera angle.

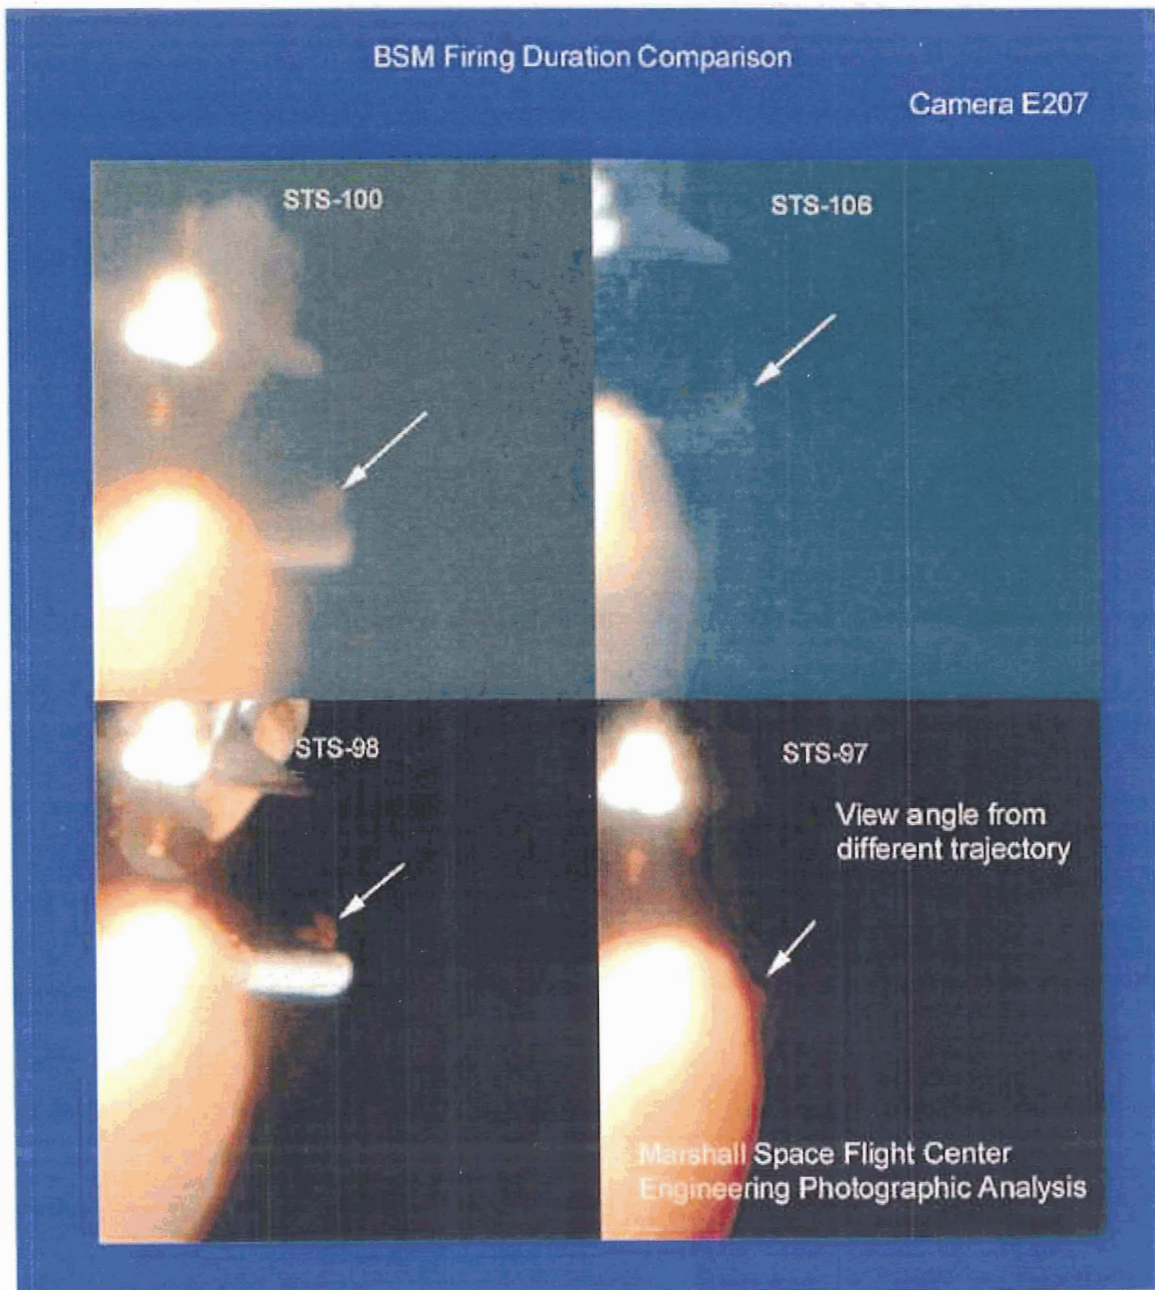
Figure 16. BSM Firing Duration Comparison

A movie of BSM motors firing after separation was made to compare firing duration from STS-100 and three recent missions. It was found that the duration of the BSM firing was approximately the same on the three missions STS-100, STS-106, and STS-98. The trajectory of STS-97 was different than the other three missions and booster motor plumes obscured the completion of its BSM firing.

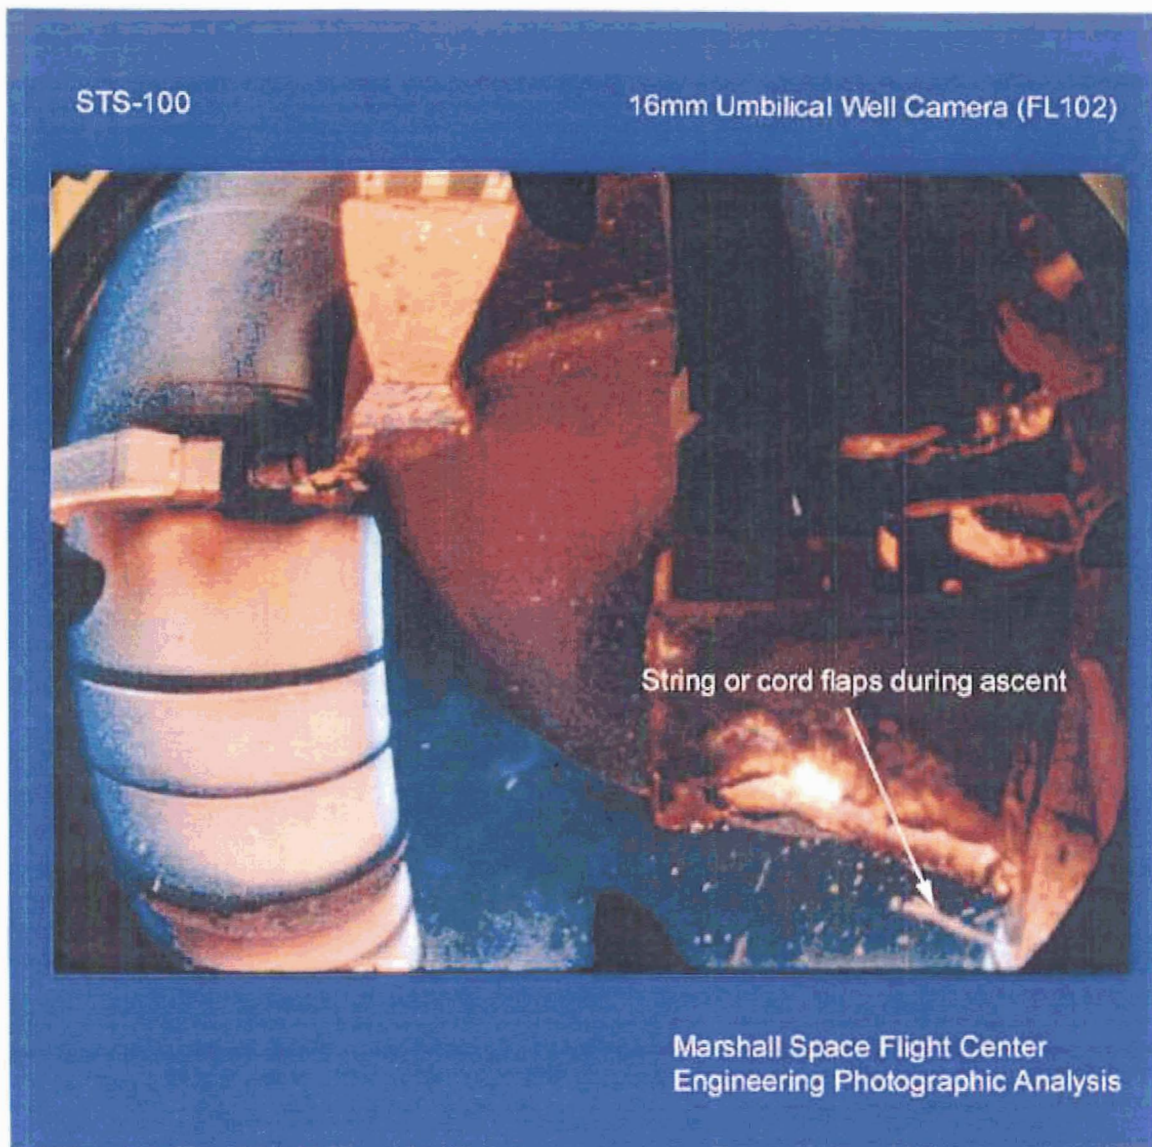
Figure 18. Tape-like Strand at Separation

16 mm Umbilical Well Film Camera FL102: Tape-like Strand at Separation

A long tape-like strand noted before and after separation. Although not imaged below, the strand extended past the fiducial mark on the film in later frames.

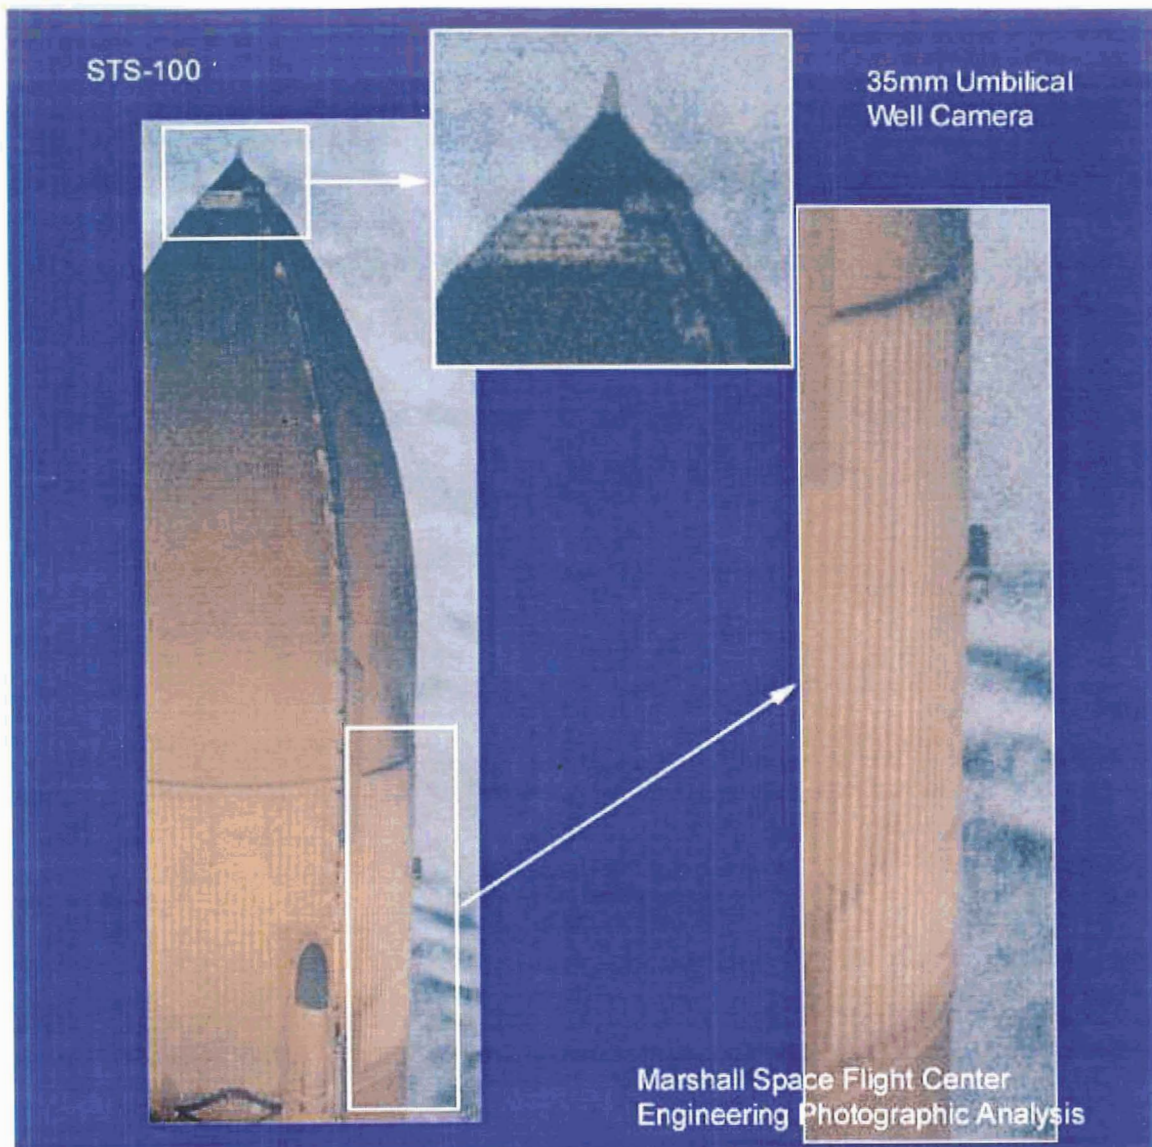
Figure 21. Close View of ET Nosecap and Right SRB Thrust Panel

35mm Umbilical Well Camera: ET Nosecap and Right SRB Thrust Panel

Close up views of the ET nosecap and the right SRB thrust panel. Both structures appeared normal with no notable divoting.

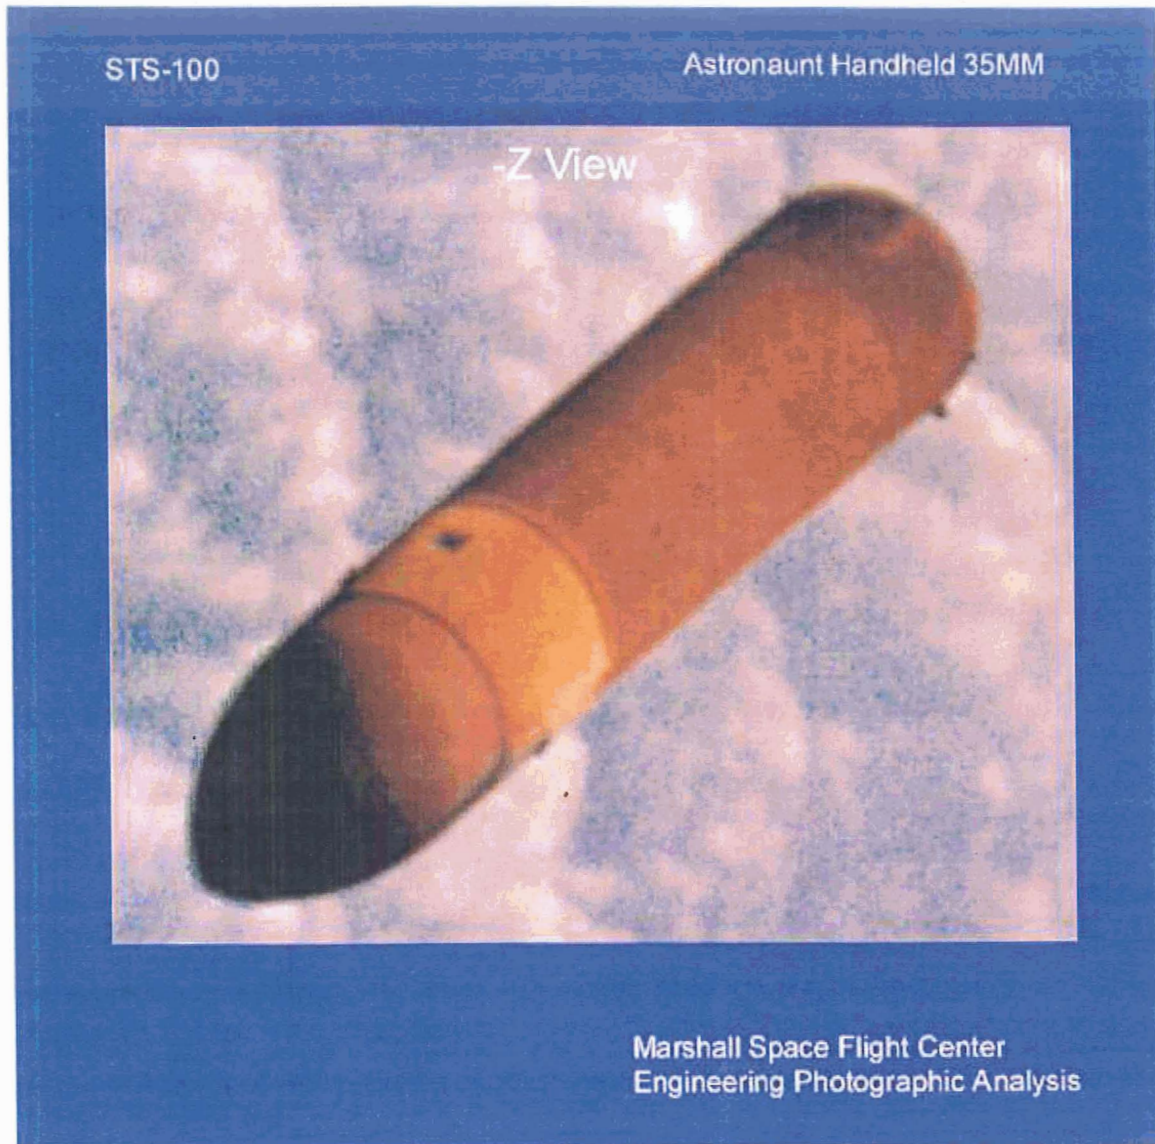
Figure 24. -Z View of External Tank

Astronaut Handheld 35mm Camera: -Z View of External Tank

No damage to the -Z side of the External Tank was observed at the resolution of this image.

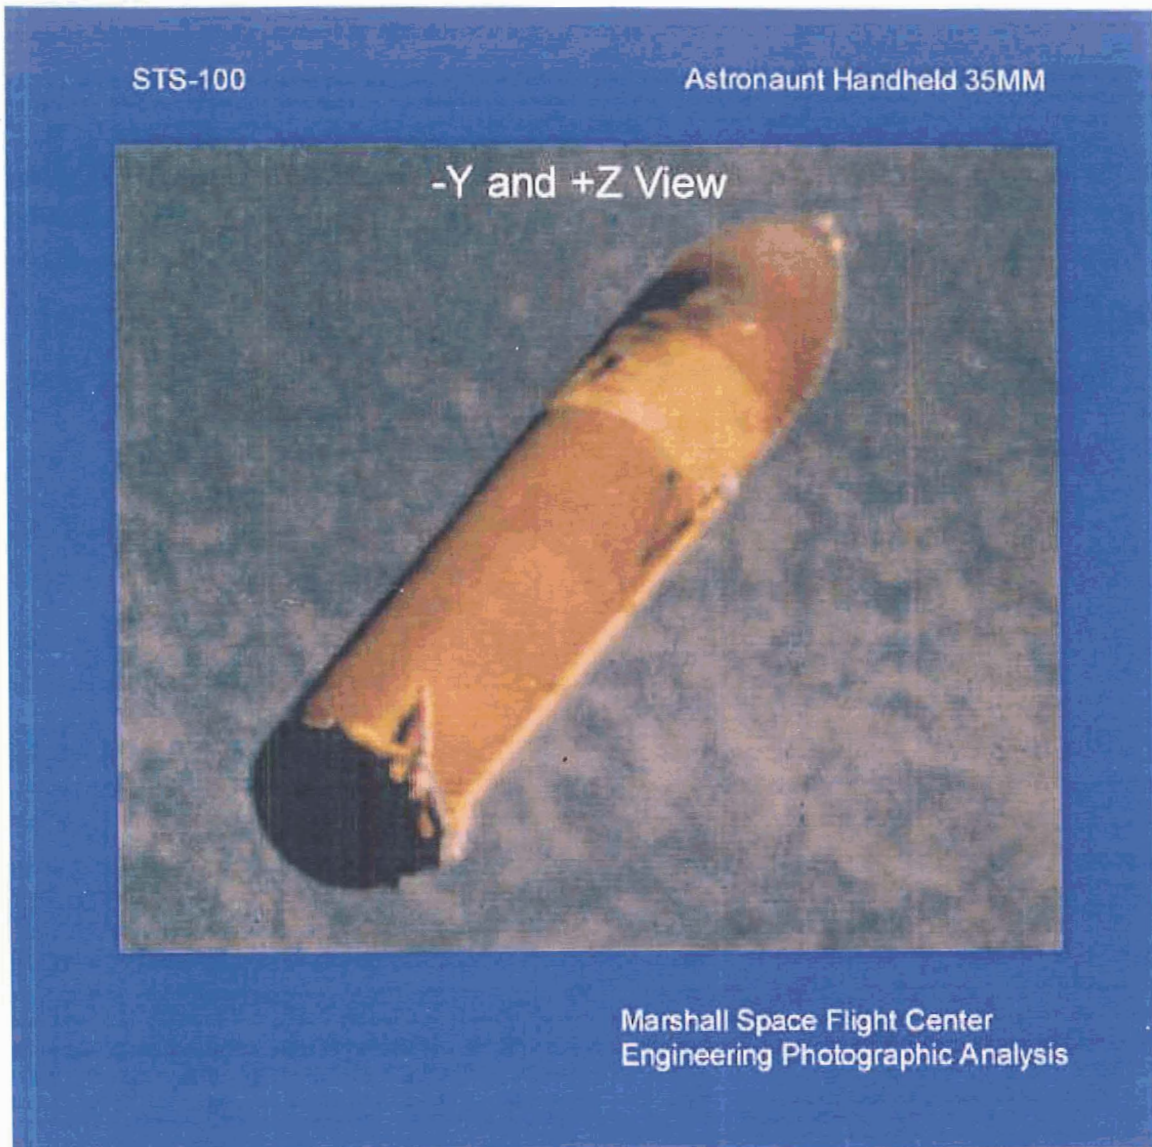
Figure 25. -Y and +Z View of External Tank

Astronaut Handheld 35mm Camera: -Y and +Z View of External Tank

The BSM burn scars are visible on the -Y side of the External Tank. No damage to the External Tank was observed at the resolution of this image.

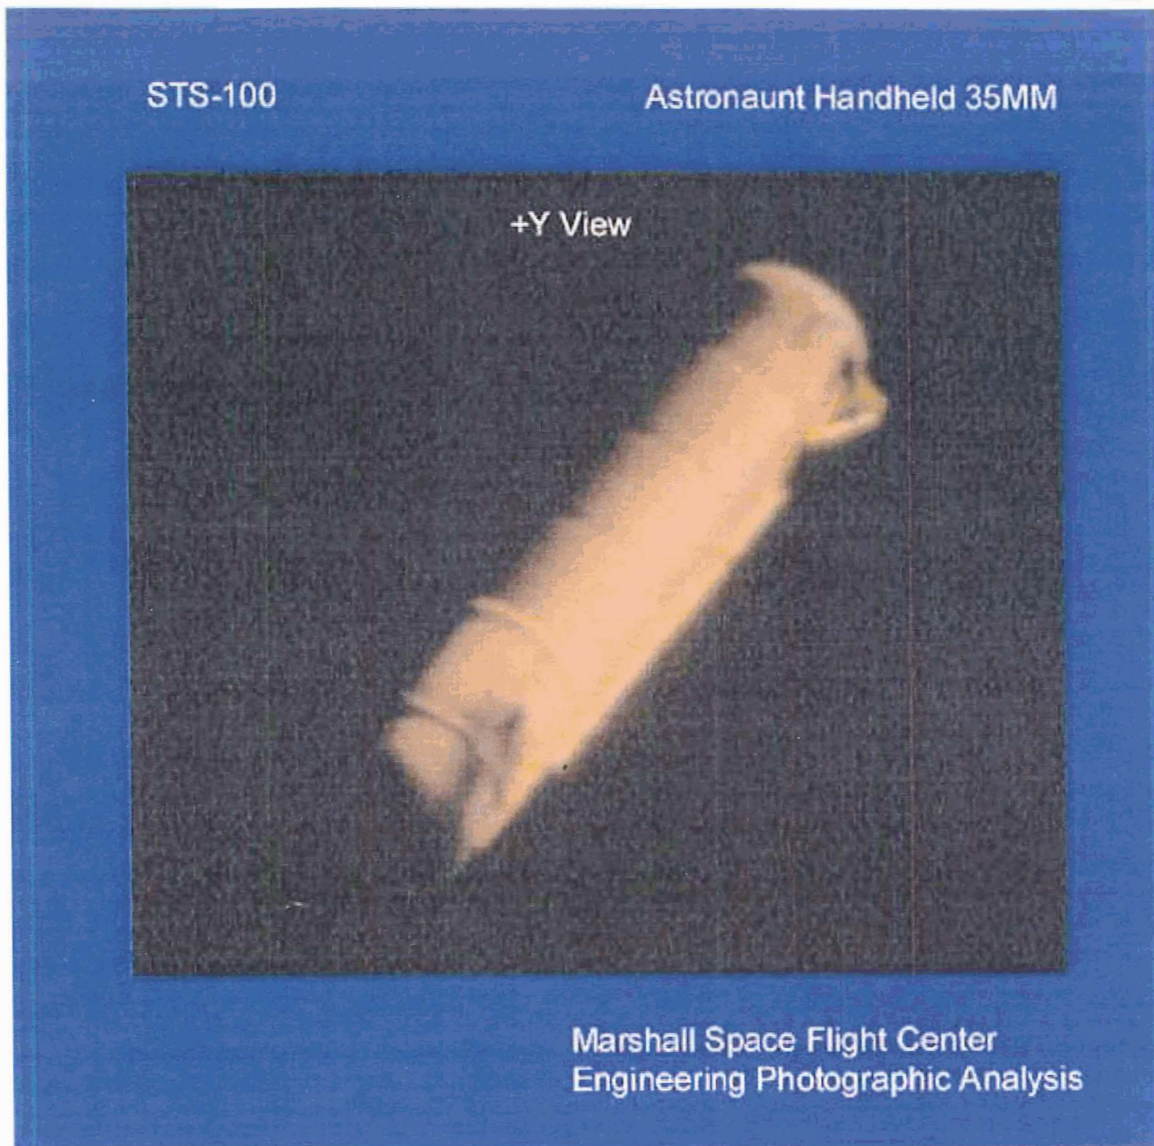
Figure 26. +Y View of External Tank

Astronaut Handheld 35mm Camera: +Y View of External Tank

The BSM burn scars are visible on the +Y side of the External Tank. No damage to the External Tank was observed at the resolution of this image.
